Program Layout and Design

Structural Review

Exterior Elevation Notes: Emery Grover Building, Needham, MA

Date: **July 28, 2010**

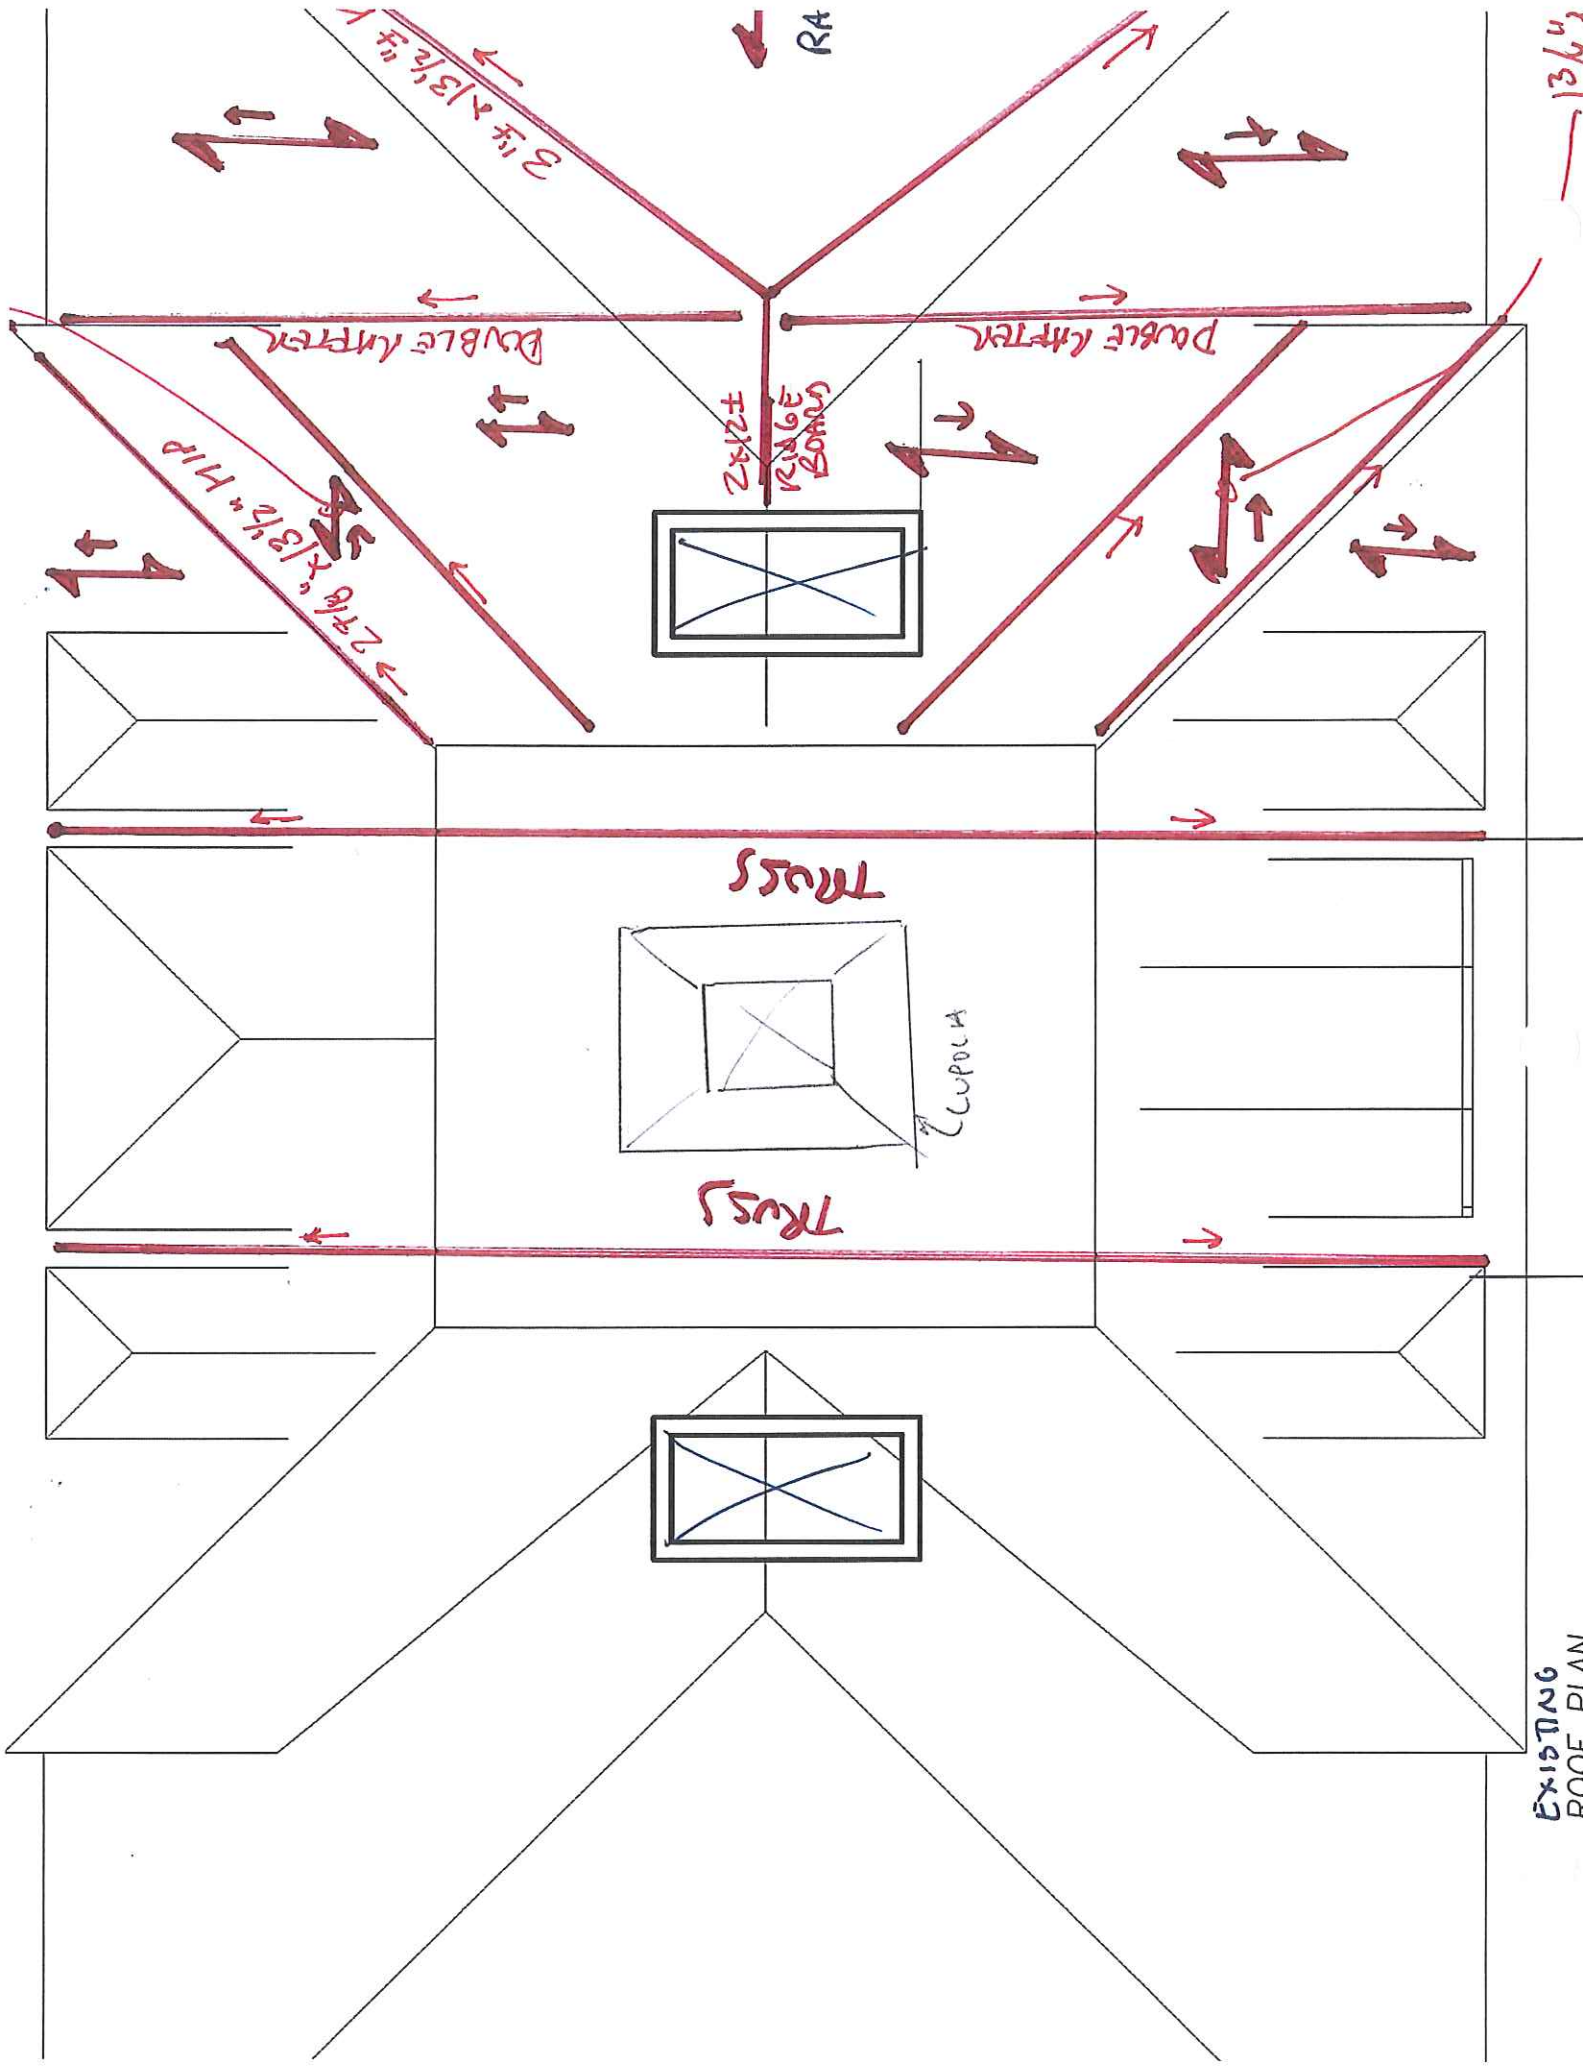
EXISTING
ROOF PLAN

Not all attic framing was visible during Structures North's site visit. Snow guards were observed on the east and west sides of the building. It is assumed that the guards were not a part of original construction, and it is unknown whether the roof was evaluated or is capable of supporting the additional snow loads caused by snow guards. **The roof might need a full evaluation, and if found to be undersized, reinforcing and/or additional columns installed.**

Not all attic framing was visible during Structures North's site visit. Joists and beams that we were able to observe typically had mortise and tenon connections when supported by other wood beams. The tenons were relatively small, likely only one or two inches tall. At several locations, horizontal splits in the supported framing were observed originating at an edge of tenon and extending several feet along the length of the member. Joists often had a small (1/4" to 3/8"+/-) gap between their ends and the supported member. Light gage metal joist and beam hangers, such as Simpson face mount hangers, should be installed throughout the building (all floors) at mortise and tenon connections.

Existing framing condition is unknown. Although current office tenants mentioned leaking roofs, rotted window sills, and animal infiltrations, attic joists appeared to be in acceptable condition where we observed them. We would recommend allowance for possible rot problems where joists bear on masonry, especially at exterior walls. This assumption is especially applicable where we noticed bulges and waviness in exterior walls. **Assume that new PT ledgers will need to be installed, and existing joists fastened to the ledgers, an operation which would require temporary shoring of joists throughout the building.**
